## WEST VIRGINIA HISTORIC PROPERTY INVENTORY FORM

<b>Street Address</b> 2935 Shepherd Grade	<b>Common/Historic Name/Both</b> <div style="text-align: center;"> <input type="radio"/>      <input type="radio"/>      <input checked="" type="radio"/> </div> Wild Goose Farm	<b>Field Survey #</b>	<b>Site # (SHPO Only)</b>	
<b>Town or Community</b> Shepherdstown	<b>County</b> Jefferson	<b>Negative No.</b>	<b>NR Listed Date</b>	
<b>Architect/Builder</b> Unknown/Unknown	<b>Date of Construction</b> Ca. 1810 with additions or modifications 1842-1845; 1880;1920	<b>Style</b> Mid 19 <sup>th</sup> -century Greek Revival; late 19 <sup>th</sup> -century, early 20 <sup>th</sup> -century Colonial Revival		
<b>Exterior Siding/Materials</b> Mansion: Wood/weatherboard; Springhouse, smokehouse, carriagehouse: stone	<b>Roofing Material</b> Metal	<b>Foundation</b> Stone		
<b>Property Use or Function</b> <div style="display: flex; justify-content: space-between;"> <div>           Residence      <input checked="" type="radio"/>            Commercial    <input type="radio"/>            Other            <input checked="" type="radio"/> Farmstead         </div> <div> <b>UTM#</b>            Z18 E257100 N4373760

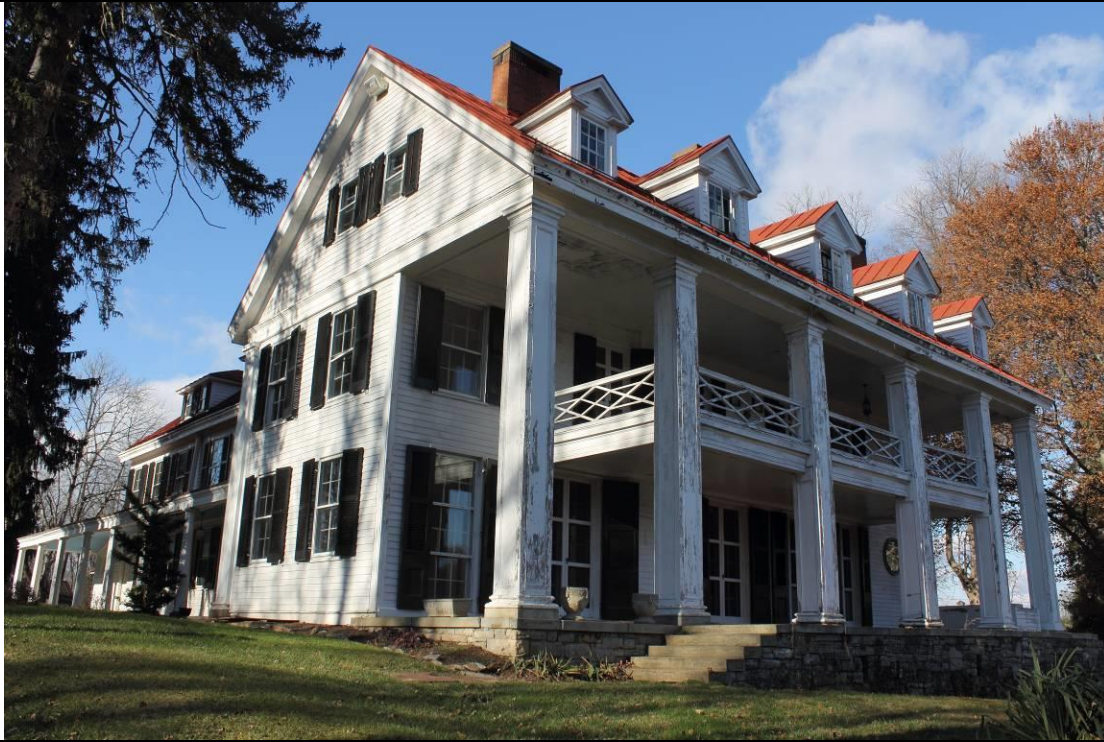
WV\_Jefferson County\_Wild Goose Farm\_0001  
Mansion exterior, south and east elevations, view NW

At the head of the entrance lane stands the main house, a wood sided frame building with an imposing square columned portico across the east elevation. It is generally U-shaped with gabled roofs. The building is sided entirely with lapped wood weatherboarding, vertically sawn and with a small bead and attached for the most part with wire nails. The house exhibits three main construction campaigns, one in the early 19th century, ca. 1810, comprising the west wing; the major construction phase in the 1840s, consisting of the east wing and hyphen linking to the pre-existing section, and a Colonial Revival remodeling resulting in the east portico, raising the roof and adding dormer windows.

The east façade of the house is five bays in width, with French doors flanked with louvered shutters. A large portico, an early 20th century addition, is under the main roof span. Construction of the portico and attendant expansion of the roof system in height and width to accommodate the portico, increases the depth of the house by about one-third, and creates a third floor living space. The two-story portico columns are square and paneled, Colonial Revival style elements added in the early 20th century. The three central bays have a second story porch with French doors opening onto it and a Chippendale-reminiscent revival style balustrade. Windows that are not French doors are six over six double hung sash. Five gable-roofed dormer windows extend from the east slope of the roof, also part of the early 20th century enlargement and renovation of the house. Three large brick chimneys, set with their long sides parallel to the roof ridge extend from the east slope of the roof, just below the peak.

The south elevation is two stories with a one story porch along the length extending from the west wall of the east wing, with octagonal columns. The one story porch spans the length of the six bay façade and wraps around the west side, but the west porch was enclosed in the early 20th century. The east wing projects forward, adding two more bays east of the portion covered by the porch, along with the bay-width east portico. A flat pilaster forms the southwest corner of the east wing, matching the portico column at the southeast corner. The pilaster and column terminate with a frieze band running across the gable end of the east wing.

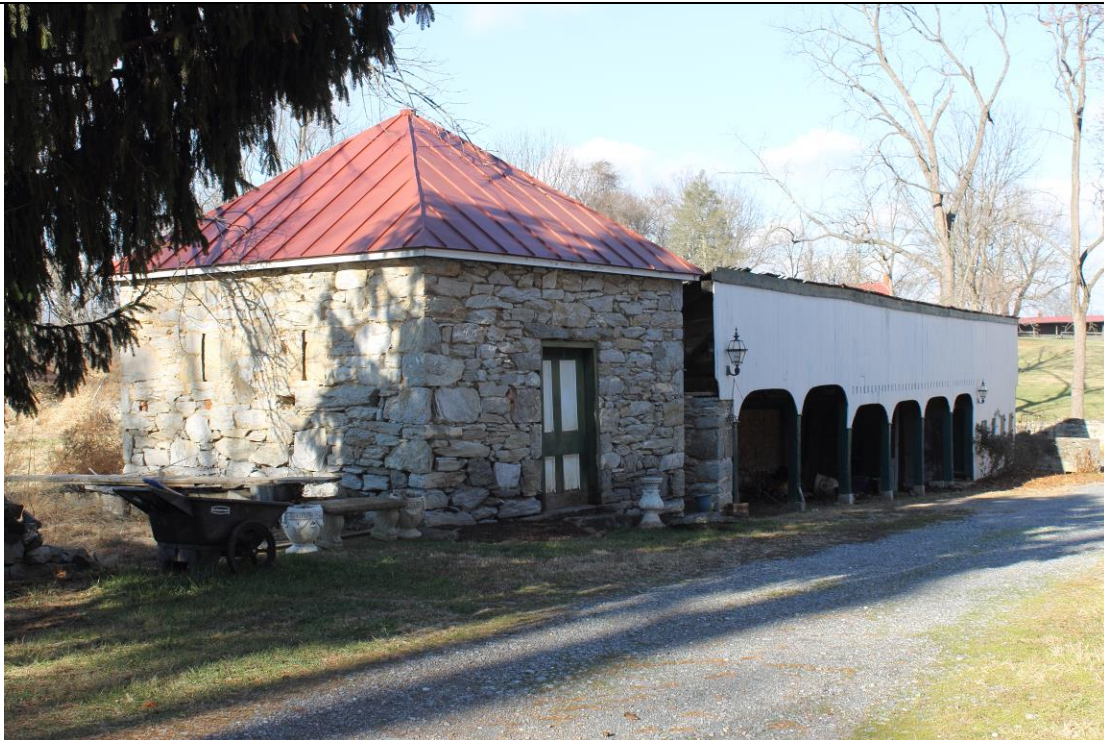
WV\_Jefferson County\_Wild Goose Farm\_0014  
Smokehouse and Carriage Shed, south and east elevations, view NW

A stone smokehouse stands directly to the west of the main house. A square hip-roofed building, it has a door in its east elevation, and vertical ventilator slits in the other walls. The building is constructed of roughly coursed rubble limestone, very unlike the highly refined masonry of the springhouse. Part of the back (west side) of the building is roughcast, and possibly the entire structure was once covered with stucco. The door has four panels trimmed with Grecian Ogee molding. The roofing material is standing seam sheet metal. Inside, a chamfered post reaches to the apex of the roof, joining the four hip rafters.

Immediately north of the smokehouse and along the driveway that wraps around the house and continues to the barn and other outbuildings, is a six-bay carriage shed with a four-window-bay enclosure at its north end. The shed roof slopes downward to the rear or west. The west wall of the building is roughly coursed rubble limestone, as well as the end walls, with the area within the slope of the shed being frame. There are six open bays supported by square posts followed by the enclosed section. The four more northerly of the open bays have dovecote openings for pigeons along the lintel. The roofing material is standing seam sheet metal.

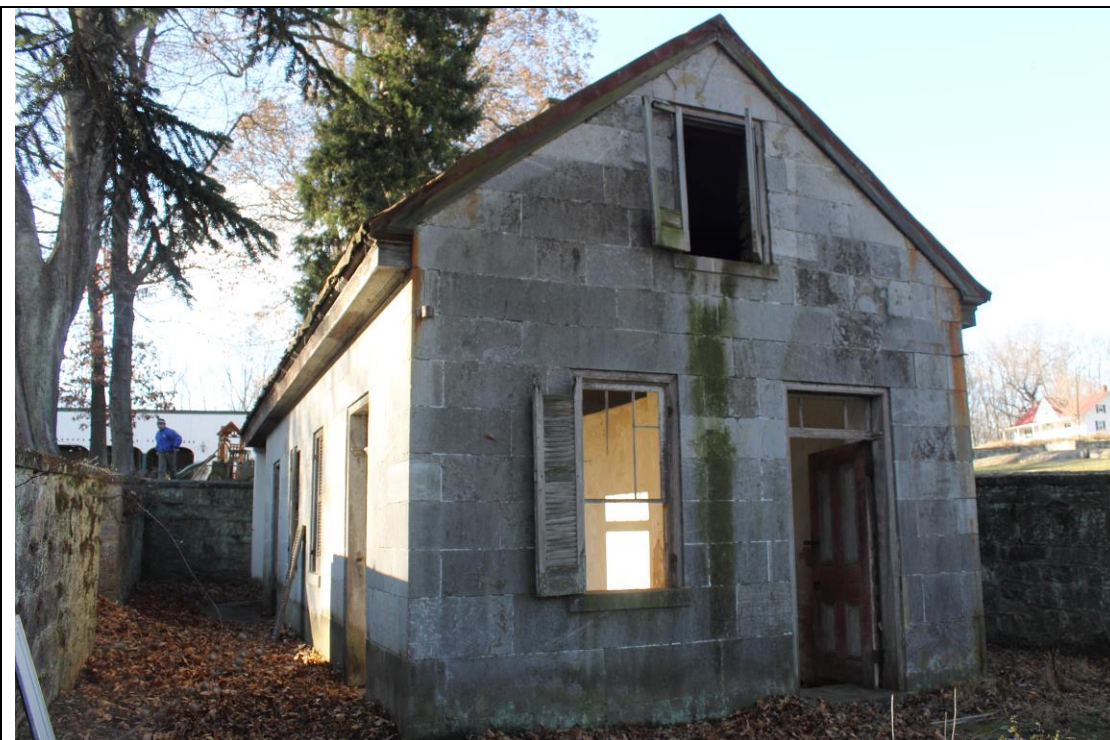
WV\_Jefferson County\_Wild Goose Farm\_0018  
Springhouse, south and east elevations, view NW

Sitting to the northeast and at the base of the hill upon which the main house stands is a multi-purpose springhouse/washhouse and dairy. A pathway paved with flat stones set within cut stone curbing leads from the back of the main house down to the springhouse. The springhouse is a four-bay gable roofed building, two bays wide. Set below ground level, it is surrounded on all four sides by coursed limestone retaining walls capped with cut stone coping. The level space surrounding the building is paved with square cut flag stones. The building is constructed of finely cut ashlar stone with narrow "butter" joints. It has an overhanging portico supported by square columns and with a pedimented gable on the west end. The roofing material is standing seam sheet metal, and a brick chimney extends from the interior.

On its south elevation the springhouse has four bays, arranged door, window, window, door. Large lintel blocks top the openings. Doors and windows have narrow mitered frames with a bead at the inner edge. Windows have remnants of nine over six light sash with louvered shutters. Doors have four panels with Grecian ogee trim and are hung beneath four-light transoms.

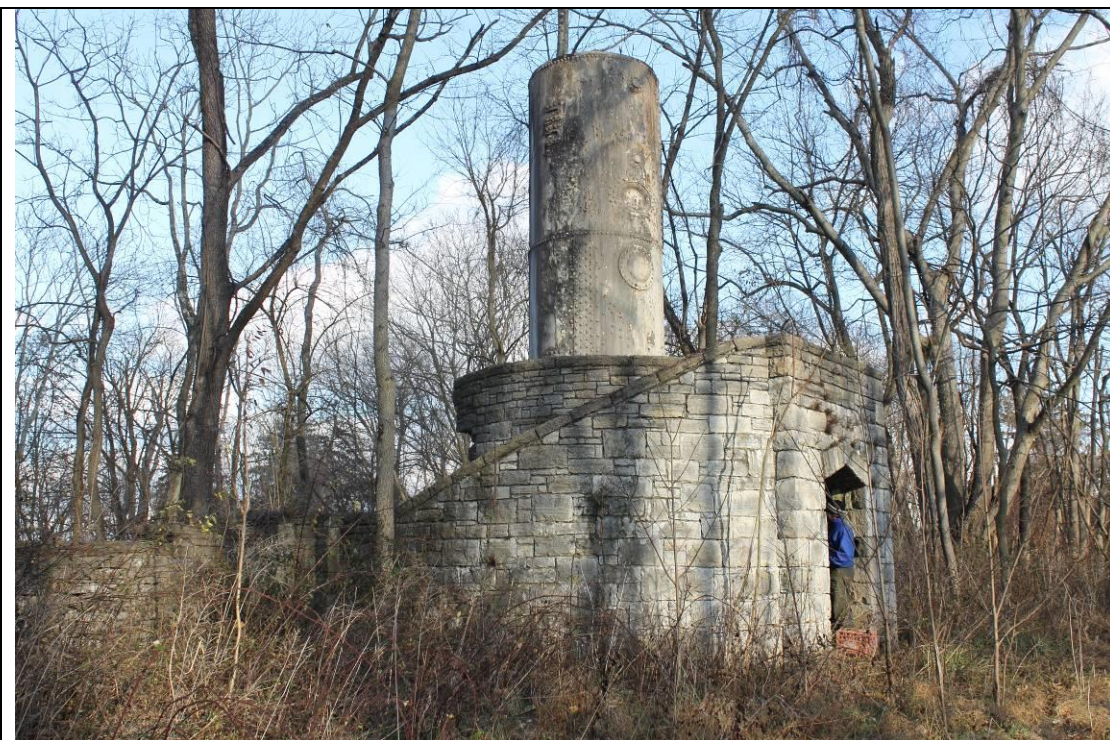
WV\_Jefferson County\_Wild Goose Farm\_0020  
Water Tower and Reservoir, view NE

In a wooded area to the southwest of the main house stands a stone encased water tower/reservoir. The reservoir consists of two cast iron cylinders, one atop the other. The bottom cylinder has a larger circumference, and has largely rusted away. The taller, narrower top cylinder rises well above the base and the stone encasement. A limestone structure with a spiral stone staircase wraps around the lower cylinder. The stairway leads to a deck on top of the lower cylinder. An entrance in the lower level of the stone structure opens to the base of the cylinder. Cast iron pipes lead into and out of the reservoir.

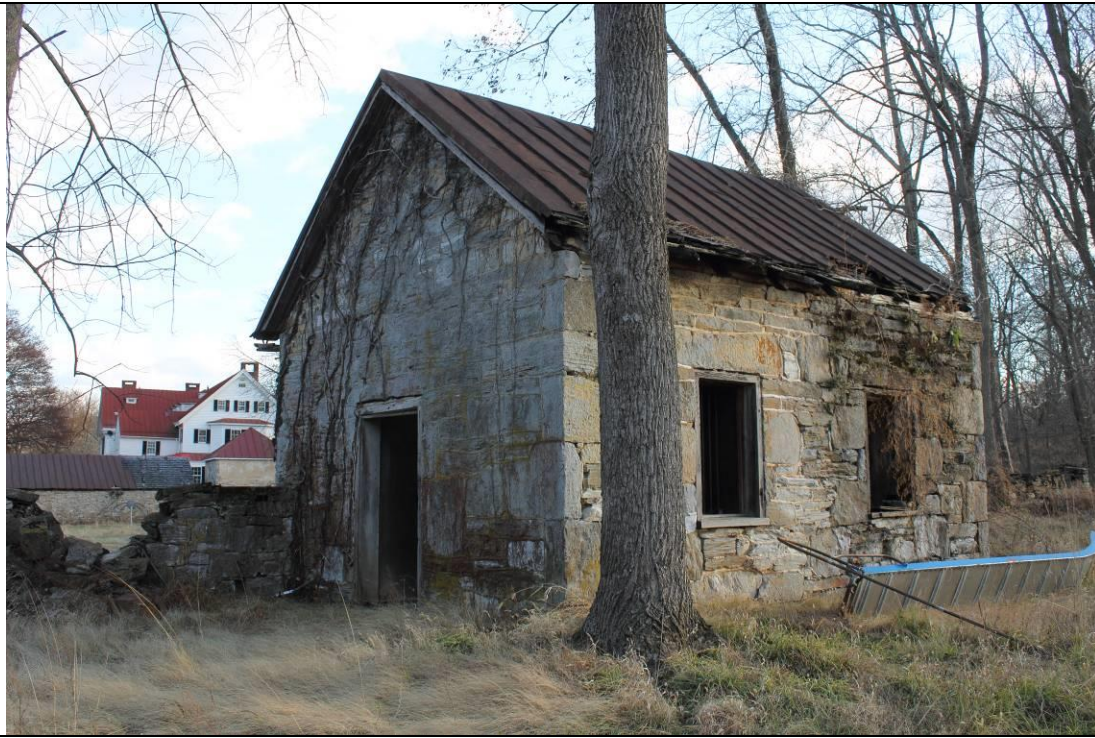
WV\_Jefferson County\_Wild Goose Farm\_0023  
Stone "plantation office," north and west elevations, view SE

Located along the roadway leading west into the fields from the building complex, this is the last building encountered. It stands on the south side of the road with its gable end facing onto the road. The function of this building is not known, but it may have been a farm or plantation office. Constructed of coursed limestone with traditional V-joint pointing, it has large stone “lintels” over the openings, typical of the second quarter of the 19th century in stone buildings of the lower Great Valley. It is a two-bay building with only a door in the east elevation, opening onto the gardens, a door in the north wall, opening onto the lane, two windows in the west wall and a long, low window in the south wall. All are framed with pegged mortised and tenoned frames of moderate width. The east door has a three-light transom. Beside the north window in the west wall, carved into the stone is the name William Wells and the date 1868. Wells, described as mulatto, was listed on the 1880 census record for Henry Shepherd, working as a coachman. The building has a standing seam roof.

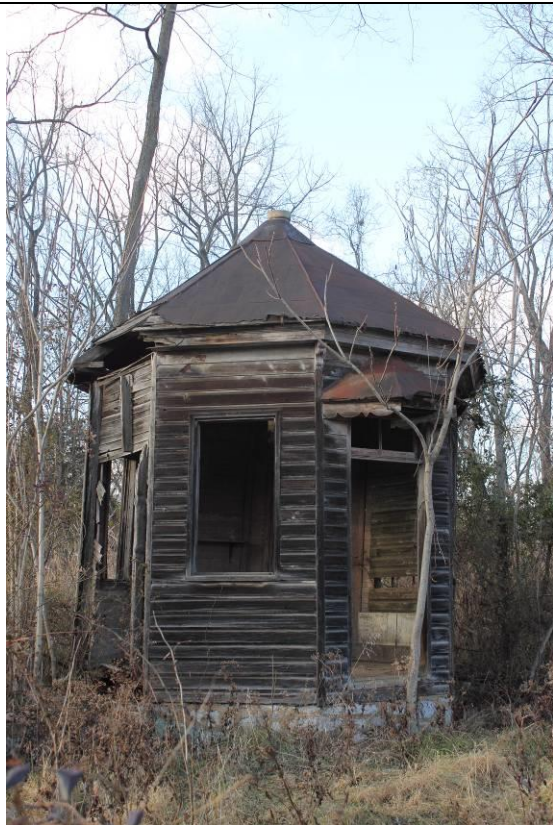
WV\_Jefferson County\_Wild Goose Farm\_0025  
Octagonal "sentinel station," view NW

This small frame octagonal building stands on the north side of the west-leading lane, just beyond the ice house. Covered with German siding with ample windows and doors, it is described as an “octagon Japanese Pagoda” in F. Vernon Aler’s history of Wild Goose published in 1888 (Aler 1888:441-443): “tastefully designed and painted, and surmounted by a gilt ball, weather cock and wild goose. Here stands the morning sentinel, who at appointed hours strikes the bell, giving signal and summons for all the workmen to repair to labor.” The interior is finished with a wooden tongue and groove floor, tongue and groove horizontal paneling and molded window and door trim. A bracket shelf remains on one wall.

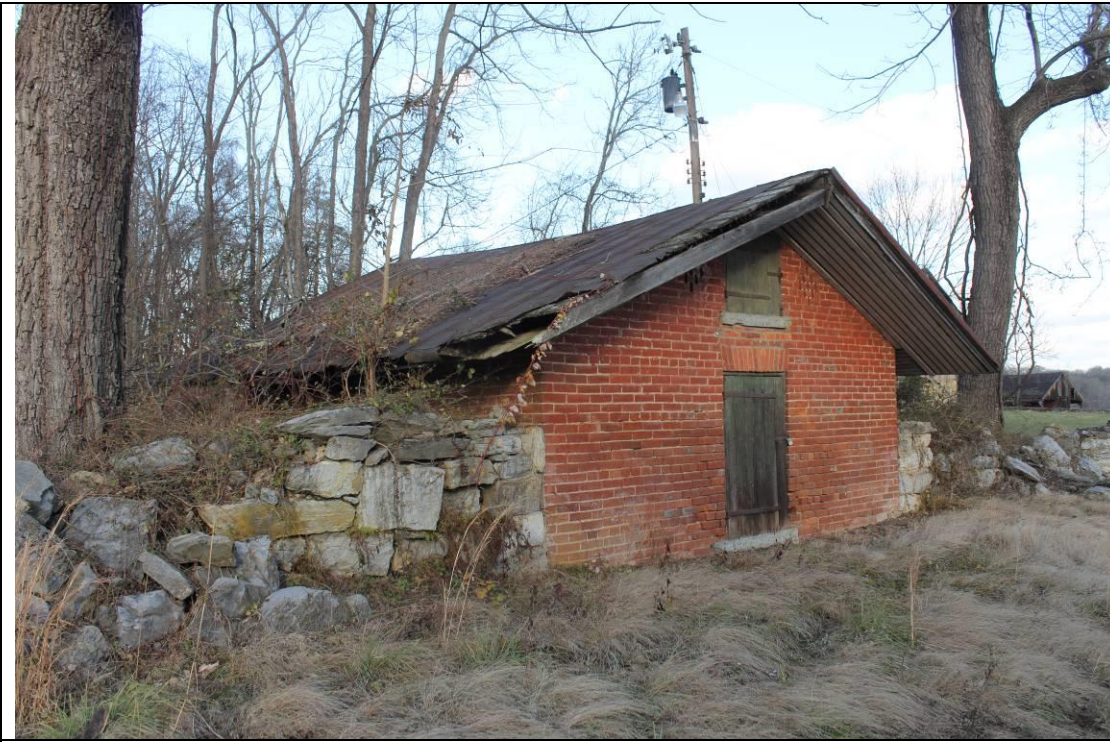
WV\_Jefferson County\_Wild Goose Farm\_0026  
Ice house, west and south elevations, view NE

Along the stone wall-lined west lane is a gable roofed brick ice house with a deeply overhanging standing seam sheet metal roof. Inside, the ice house has a deep wooden floor and shelving along the upper wall. One board is inscribed with the painted name ES Jarrett, who purchased Wild Goose in 1911.

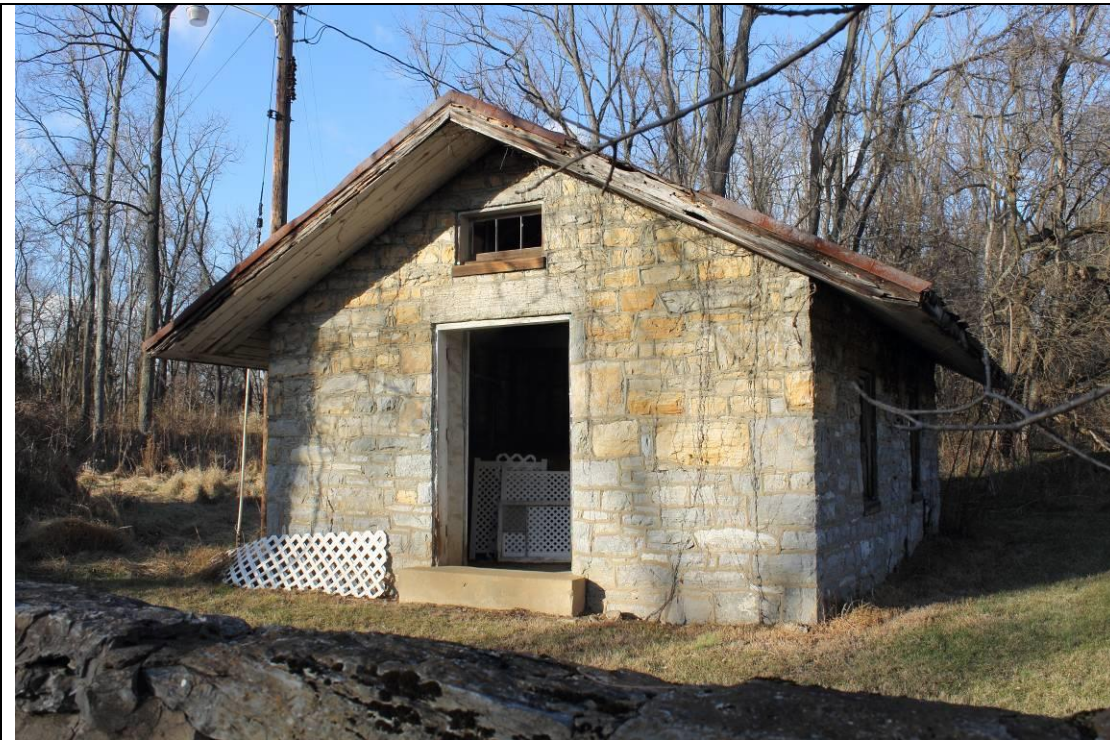
WV\_Jefferson County\_Wild Goose Farm\_0027  
Pump house, south and east elevations, view NW

At the north end of the carriage shed, the driveway intersects with another lane heading west along a stone-walled track leading to gardens and fields beyond, and lined with various utility buildings. The easternmost building is a stone pump house, which probably dates from the early 20th century, since it is not mentioned in the history of Wild Goose Farm book published in F. Vernon Aler's 1888 history of Martinsburg and Berkeley County. The two-bay by one-bay building is constructed of roughly coursed limestone with raised mortar joints. The gabled roof overhangs deeply on all sides and is covered with standing seam sheet metal. A door in the south wall opens into a single room with a large metal tank, cast iron pipes and an antique pump.

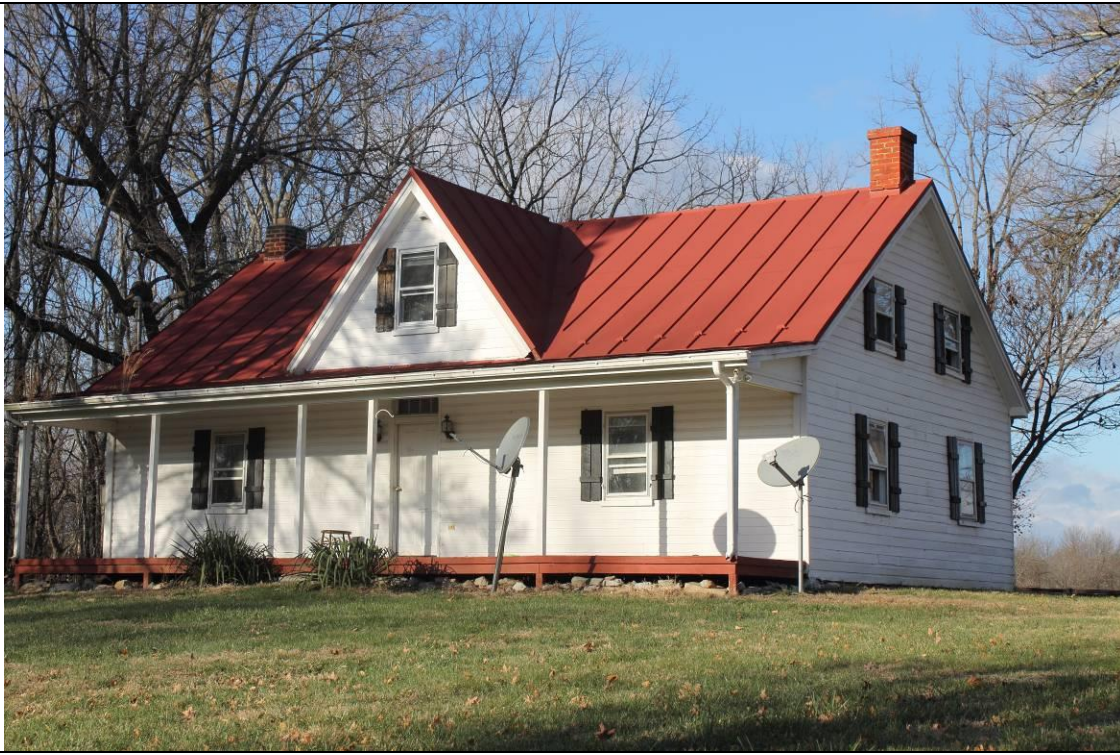
WV\_Jefferson County\_Wild Goose Farm\_0028  
Tenant house, south and east elevations, view NW

To the west of the barn behind an approximately seven-foot-high retaining wall is a frame tenant house. Resting on low limestone foundations it is a three-bay one and a half story dwelling with a one-story L to the rear. It faces south and has a prominent central front cross gable. German siding covers the walls and standing seam sheet metal the roof. Shed roofed porches extend across the entire front elevation and the east wall of the L-extension. Brick chimneys extend from inside each gable end.

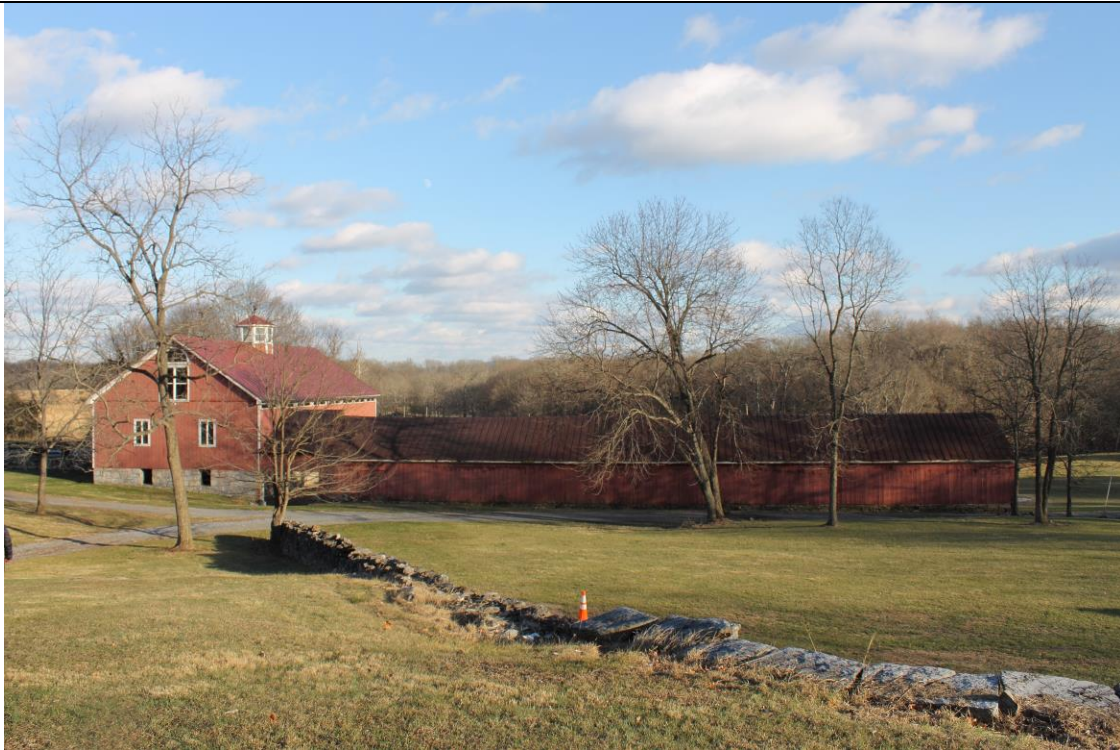
WV\_Jefferson County\_Wild Goose Farm\_0030  
Barn and attached shed, west elevation, view NE

The barn complex stands north of the house and the springhouse. The centerpiece of this connected grouping is the frame Pennsylvania type bank barn dating from 1842-1845. It faces south and has a closed forebay, resting on the extended limestone foundation walls. Attached to the west side of the south elevation of the barn is a long row of shed-roofed bays, also dating from 1842-1845, to house livestock and a harness room. A drive-through bay attaches this shed extension to the barn. Behind the barn at its northeast corner is a poured concrete stave silo, probably dating from the 1910-1920 period. The barnyard is walled with a coursed limestone fence, fallen in places. Cut stone coping tops the fence. A distinctive feature is a round arched opening at the juncture of the fence and the stone forebay wall, presumably creating an opening for livestock to exit the barnyard into the pastures. The arch stones are finely cut and the structure is topped with the same finely cut cap stones as the rest of the fence. Additionally the walkway under the forebay and along the front of the livestock sheds is paved with coursed stones edged with cut stone curbing.

The barn is a braced frame structure constructed of hewn timbers and is typical of the Pennsylvania, Maryland, eastern West Virginia and northern Virginia cultural region. The siding has been replaced and windows added in recent years along with a polygonal cupola mounted with the Wild Goose weather vane. The barn's roofing material is modern snap-joint enameled metal roofing simulating standing seam metal. The lower level of the barn is very intact with two-leaved batten doors, mortised and tenoned and pegged frames and transoms; and windows with horizontal wood bars, all typical of the local region. The floors are paved with brick in a herringbone pattern, stretched side up.

The sheds retain their original beaded vertical siding. The roofing material is standing seam sheet metal. The two southernmost bays of the sheds are finely finished stalls with paneled interiors and quarter-arched windows between them. These presumably housed prize horses. The northernmost bay was for storage of harness, with hooks and hangers attached to the walls and ceilings. The area along the sheds and under the forebay is paved with cobblestones.

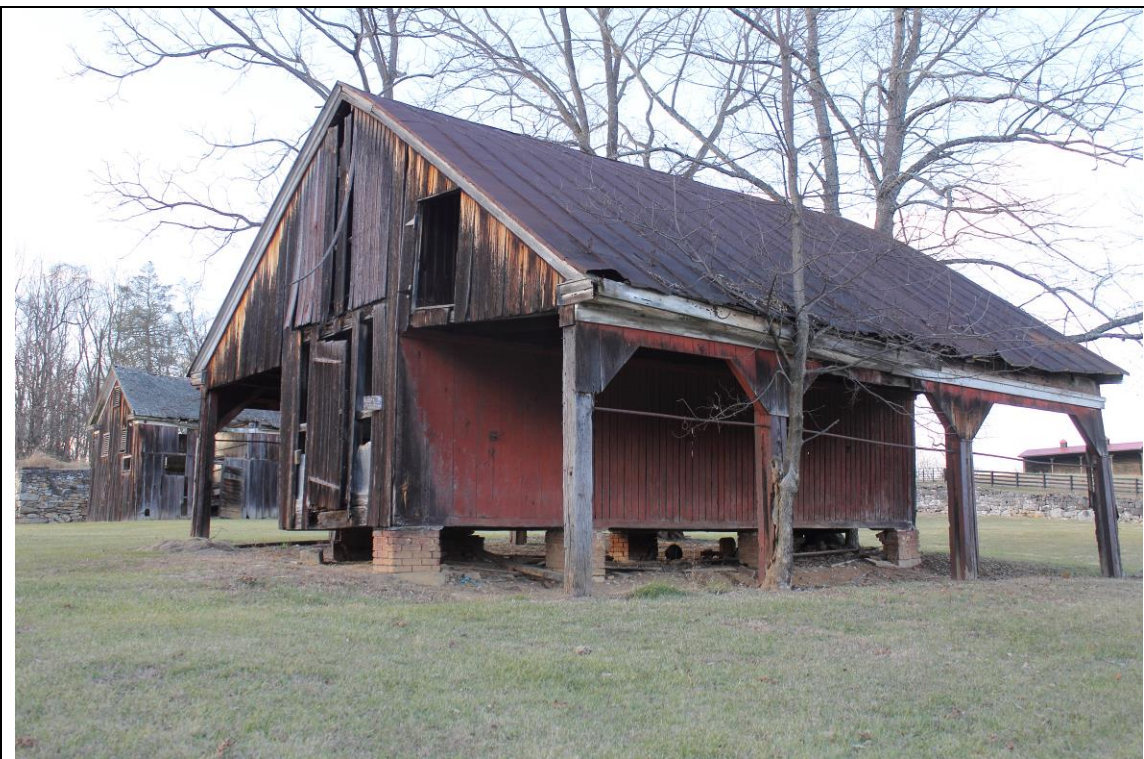
WV\_Jefferson County\_Wild Goose Farm\_0035  
Wagon shed/corn crib, south and east elevations, view NW

East of the poultry house is a frame, gable roofed wagon shed/corn crib. Although these structures are quite common on farmsteads of the eastern panhandle of West Virginia, this one is unusual in that the corn crib is central with the wagon bays on the outsides. Regional wagon sheds have a central wagon bay with the corn

cribs on the outside. This building rests on brick piers and is covered with vertical siding, much of which has been replaced. The roofing material is standing seam sheet metal.

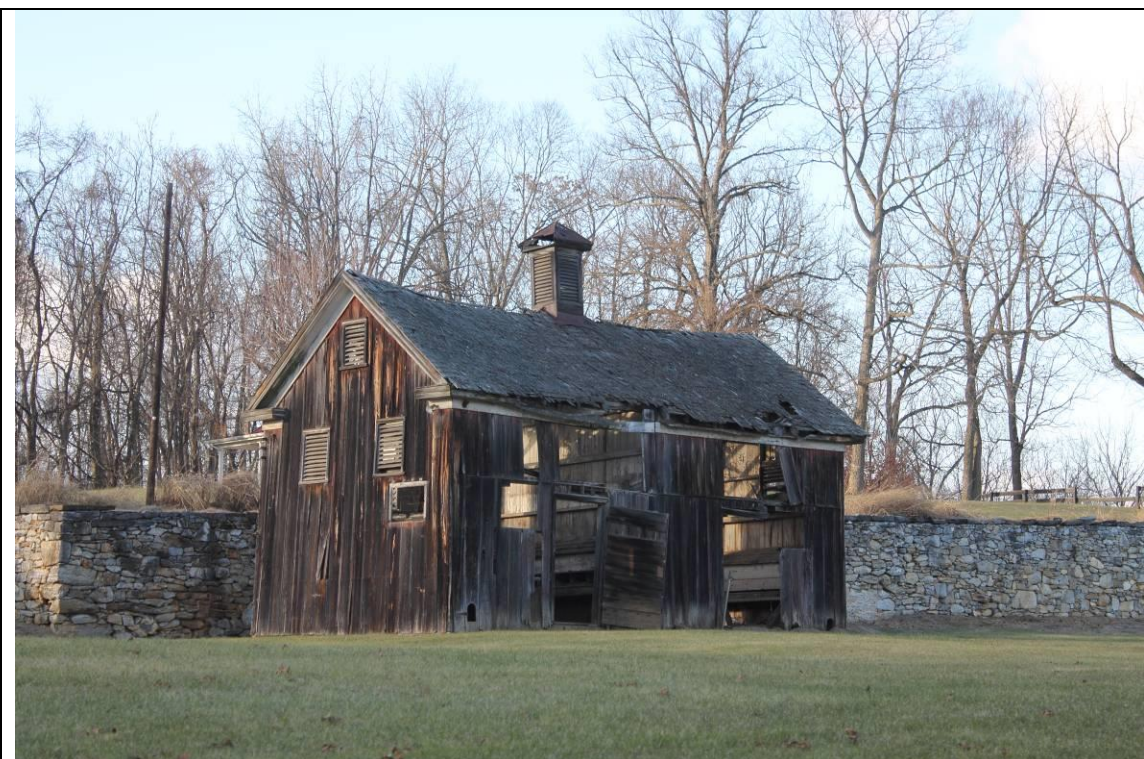
WV\_Jefferson County\_Wild Goose Farm\_0036  
Poultry house, south and east elevations, view NW

The poultry house is a gable roofed frame building with vertical board and batten siding. It is covered with a deteriorated wood shingle roof and topped with a square cupola with louvered vents. The building is divided into two chambers with a loft above. Each chamber has a door and a window in the east façade, and at each end a small arched opening for the birds to enter and exit. The interior features feed bins and nesting boxes.
